NAVY DEPARTMENT
BUREAU OF NAVIGATION

CASE INSTRUCTION

SERIAL NUMBERS 1 TO 10
COLLISION CASES

*Prepared by the
Training Division
Bureau of Navigation*

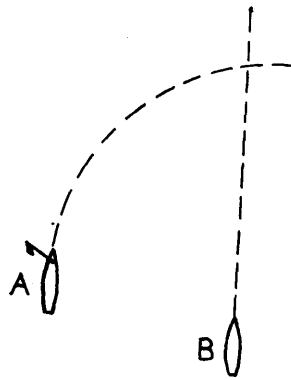
Fig. 2.

Position of A, B & F at 0030
A & F changing course to 0°
B changing to 185°

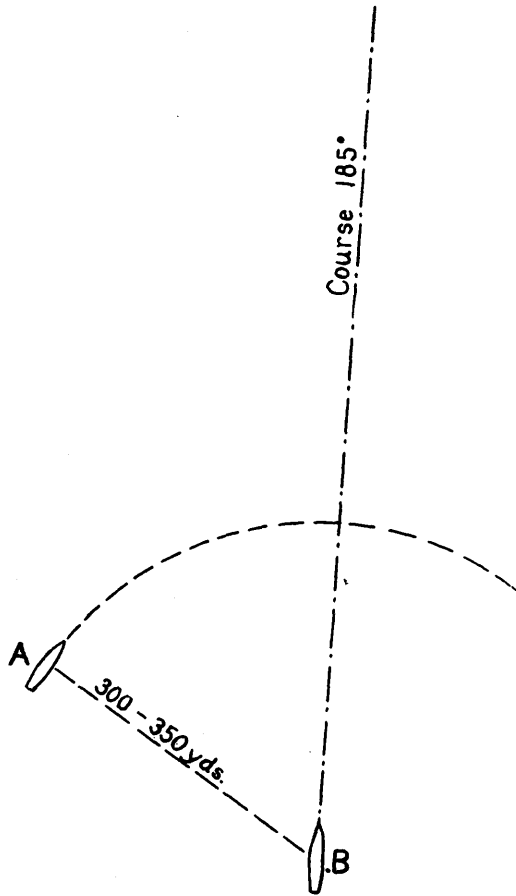
Fig. 3.

About a minute later, or at 0034, "B" rammed "A," striking her just forward of the bridge at an angle of about 40° abaft the beam. "B's" heading at the instant of collision was about 220° true. Her estimated speed through the water was 4-6 knots. "A" was practically dead in the water.

Situation at 0033

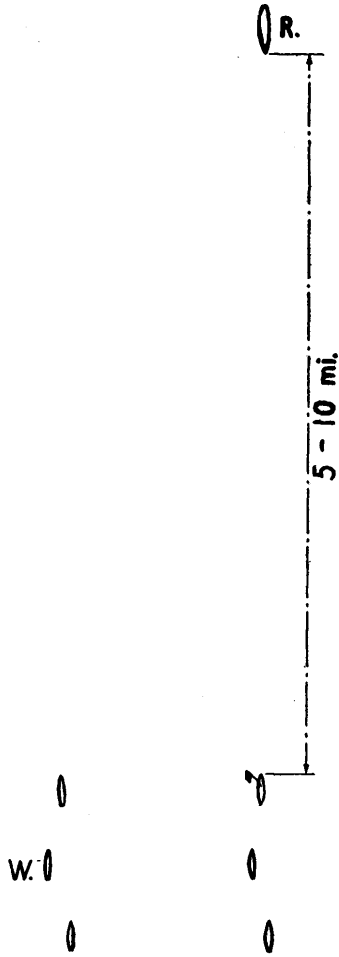
Fig. 1.

Position when lights were first seen at 0038 - Zone
 + 5 time. Destroyers course 302° true.
 Robin's course 110° true.

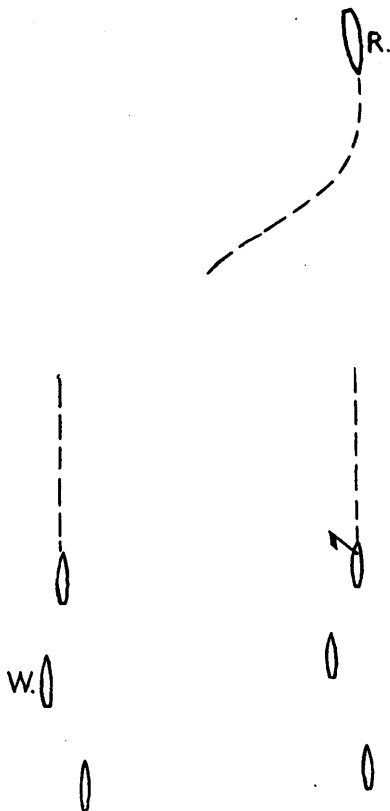
Fig. 2.

Approximate positions when
Robin put her rudder right.

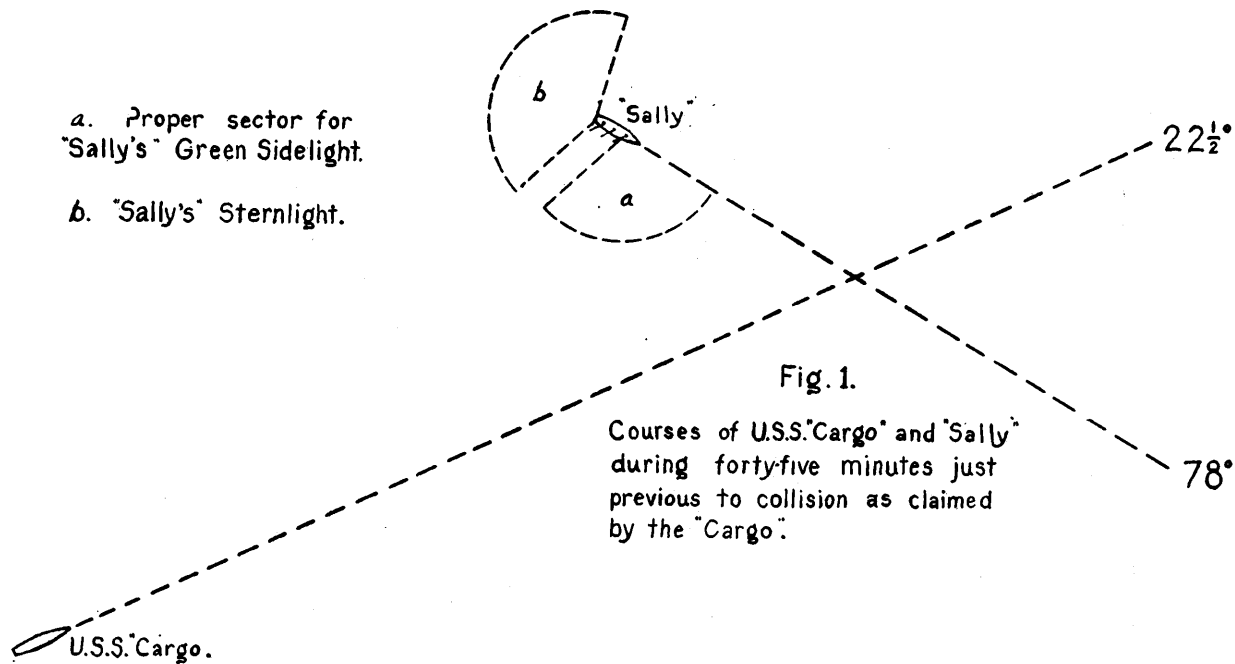
a. Proper sector for
"Sally's" Green Sidelight.

b. "Sally's" Sternlight.

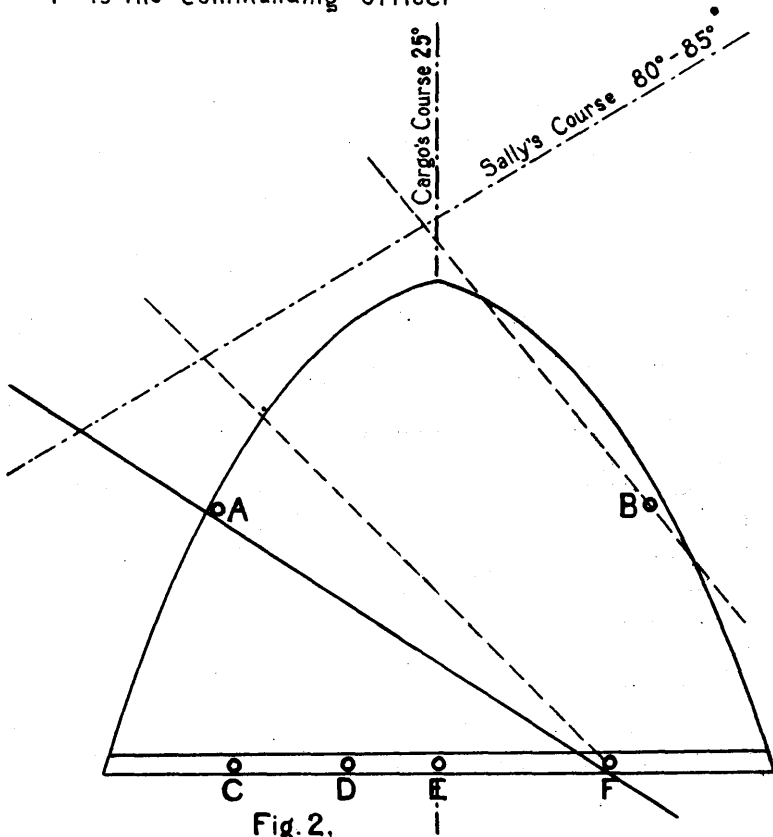
Fig. 2.

The light appeared white to all below the solid line and green to F, the commanding officer, until the schooner was close aboard, when it also appeared green to A it did not show green to B until it came in line with the bow.

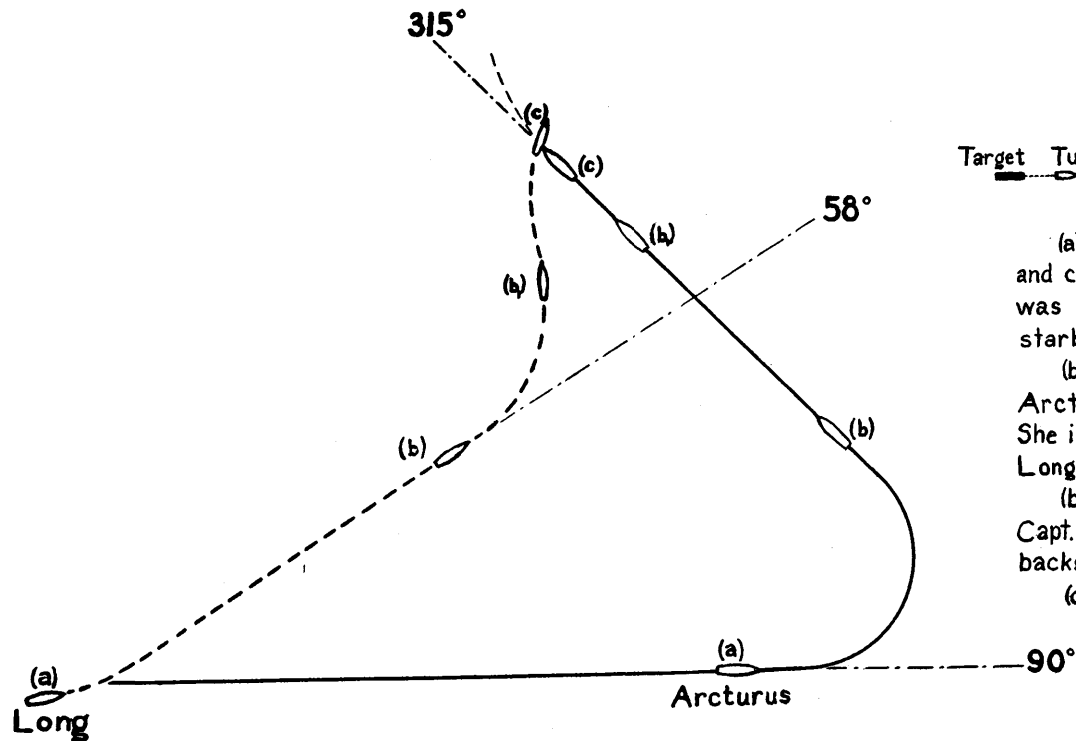
(a) Arcturus blew two blasts and changed course at 1343, Long was 2000 yds. slightly on her starboard quarter.
